Storm damage from Wednesday 9 November 2016 in Ward 74

David R Fisher

Councillor Ward 74

13 November 2016

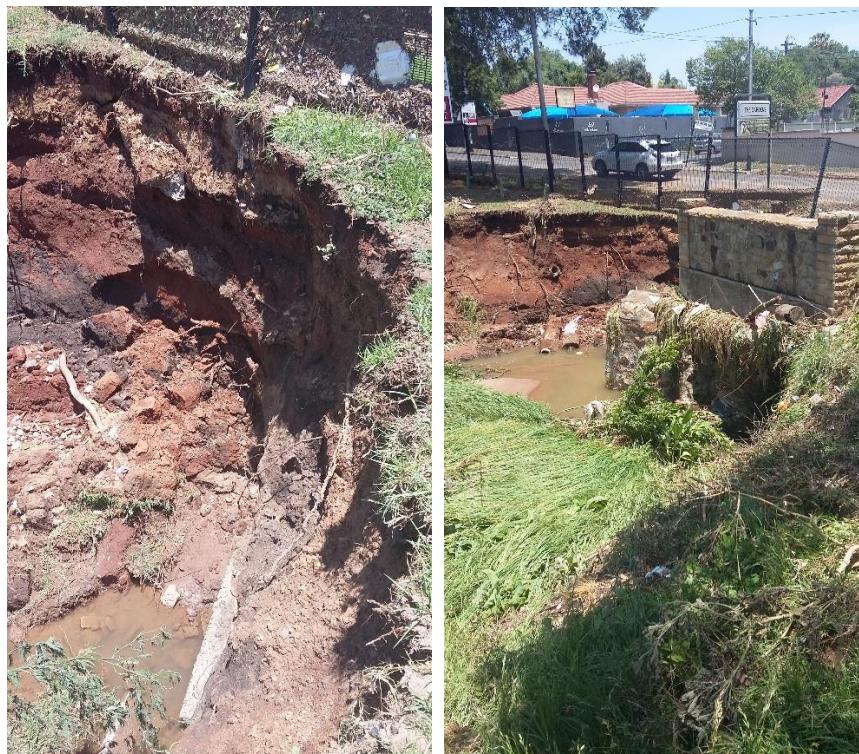
The Hilson Bridge on The Avenue in the suburb of The Gardens was the next major obstacle. The banks on the upstream side were severely eroded. The foundations are now exposed and there is no lateral support.

I addressed an email on Thursday afternoon to Khaya Mbandla, the JRA Regional Manager with copies to the Regional Director, the Integrated Visible Service Delivery Manager and my Urban Inspector expressing my serious concerns for the safety of the roadway. The first picture below shows the extent of the river wall that was eroded and the second is from the park towards the roadway. The exposed foundations are on the right of the picture.

The City will need to have a detailed investigation into the storm water management system in this area.

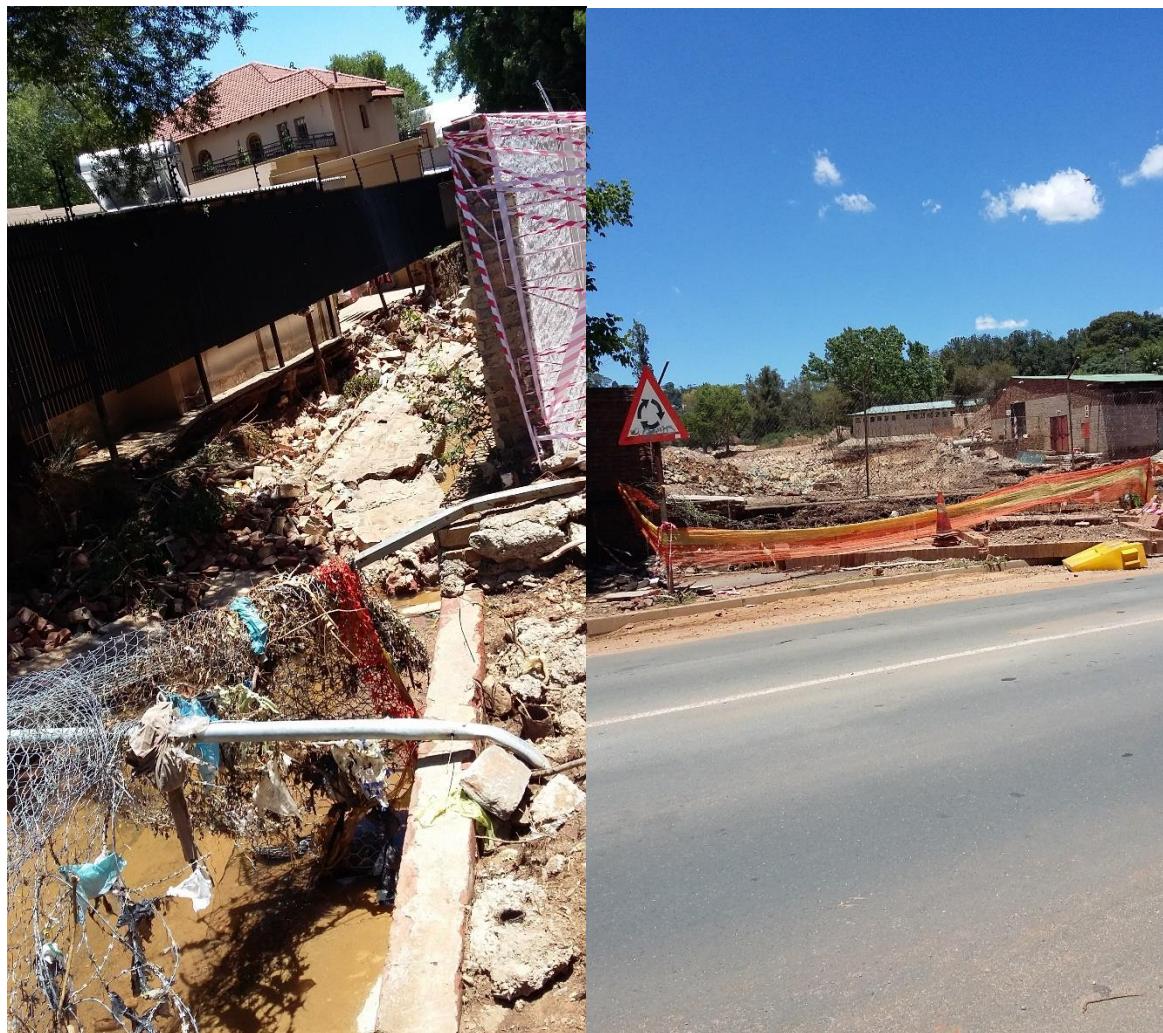
The most serious damage was caused along the line starting in the construction site of the Patterson Park re-development. Water from the Houghton Ridge dammed up against the boundary wall on the south side of Louis Rd. It eventually pushed the wall over and went across Louis Rd/Ivy Rd (they join at this point). On the north side that water pushed over boundary walls on a number of houses in a line along the culvert which was unable to contain the water. It appears that large volumes of water were added in each subsequent street, Henrietta, Garden and Oaklands Rd. Because the storm water inlets into the culvert were not able to cope with the volumes of water there were walls and fences that were pushed over to allow water to run through adjoining properties. Metal driveway gates were buckled, a stone wall had a hole breached in two places, a garden shed containing tools was swept away and not found. One resident found a bathroom bath in his garden.

The culvert going north (down stream) from Louis Rd, Looking south from Louis Rd into the Paterson Park site.

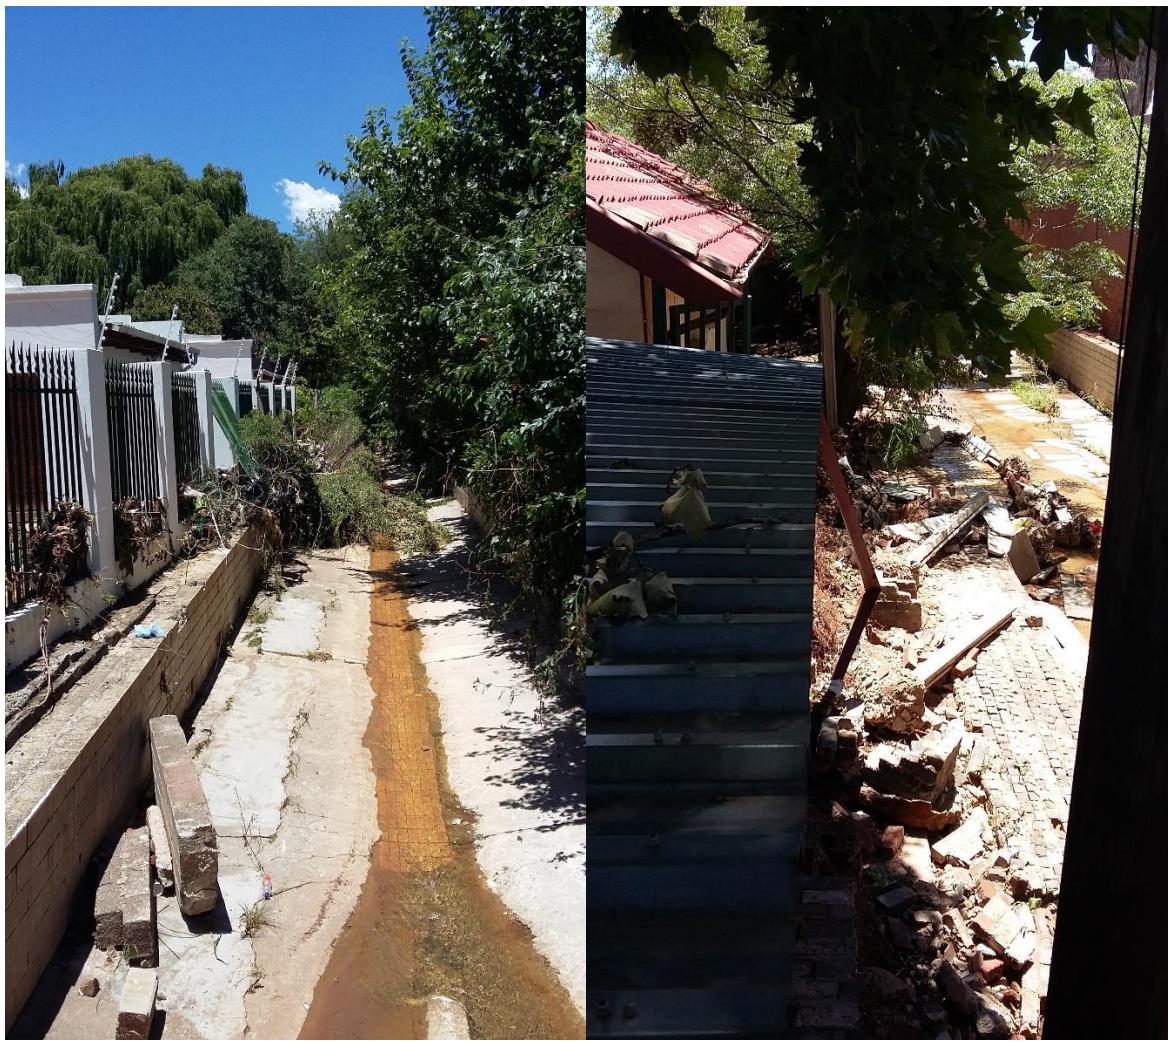
General views of the culvert showing large bits of wall that had been dumped from further up as well as a boundry wall that was pushed over into the culvert by water coming in laterally.
